Modernization and Optimization of Existing Dams and Reservoirs

27th Annual USSD Conference
Philadelphia, Pennsylvania, March 5-9, 2007

GREEN LANE GETS GREEN LIGHT: PARAMETER SENSITIVITY IN GRAVITY DAM STABILITY ANALYSIS¹

Green Lane Dam

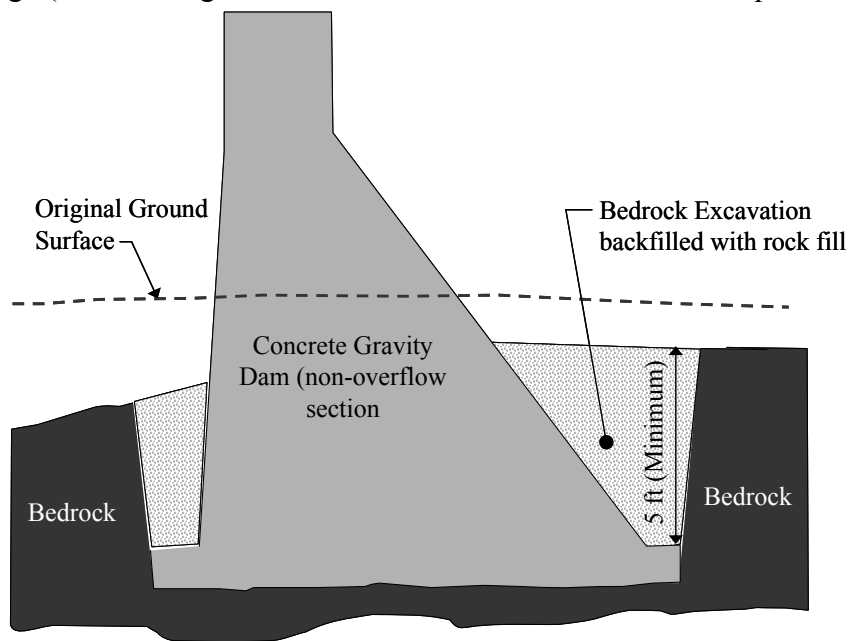
Figure 1. Typical Section – Non Overflow Portions

As-built drawings and construction photos indicated that significant rock excavation (15 to 30 ft) was performed (especially in the non-overflow sections) to construct the dam. The downstream excavation slope was near vertical, and concrete was cast directly against the rock for a minimum height of 5 ft. The remaining area between the concrete gravity section and the rock that remained was backfilled with aggregate fill (see Figure 1). Because of this geometry, sliding could not occur without mobilizing a significant rock wedge (shear through the bedrock – see next section for description of the bedrock).

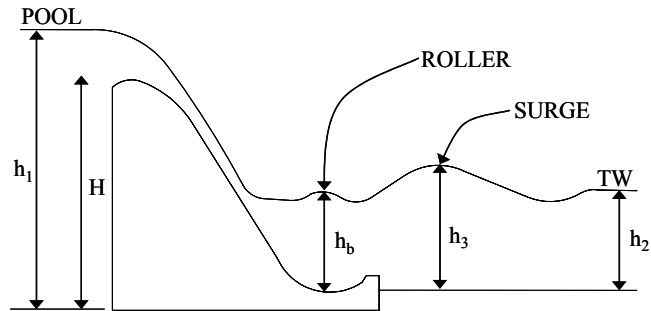
Figure 2. Roller Bucket Definition Sketch
(based on EM 1110-2-1603)

Lane Dam for various events up to and including the PMF for use in the stability evaluation. The HEC-RAS computer program was used to model flow in Perkiomen Creek between Green Lane Dam and Hill Road, located about 1,200 ft downstream. For the stability evaluation of the spillway sections, tailwater as computed in the HEC-RAS analysis was adjusted to reflect effective tailwater against the dam, as influenced by high velocity flow through the spillway and roller bucket. Model studies of the roller bucket were conducted as part of the original design. In addition, the Army Corps of Engineers' EM 1110-2-1603, Hydraulic Design of Spillways (1990) provides guidance related to roller bucket energy dissipaters. The tailwater computed in the HEC-RAS analysis was used to compute effective tailwater depth at the roller bucket. Application of the methods presented in EM 1110-2-1603 yielded very similar results to those found in the original dam design documents. For flows up to the 0.4 PMF, the original design data was used, and for greater flows (beyond the limits of original model study), the methods of EM 1110-2-1603 were applied.

Hydraulic jump energy dissipators typically reduce the tailwater to a much greater extent (down to about 60 percent of the depth in the downstream channel) than roller buckets. The effective computed tailwater for the Green Lane Dam roller bucket is to about 85 to 90 percent of the downstream tailwater depth. This additional tailwater at the dam translates to increased stability of the structure.
